CAESAR CREEK LAKE
LITTLE MIAMI RIVER BASIN
OHIO

EMBANKMENT CRITERIA AND
PERFORMANCE REPORT

PREPARED BY
U.S. ARMY ENGINEER DISTRICT, LOUISVILLE
CORPS OF ENGINEERS

SEPTEMBER 1982

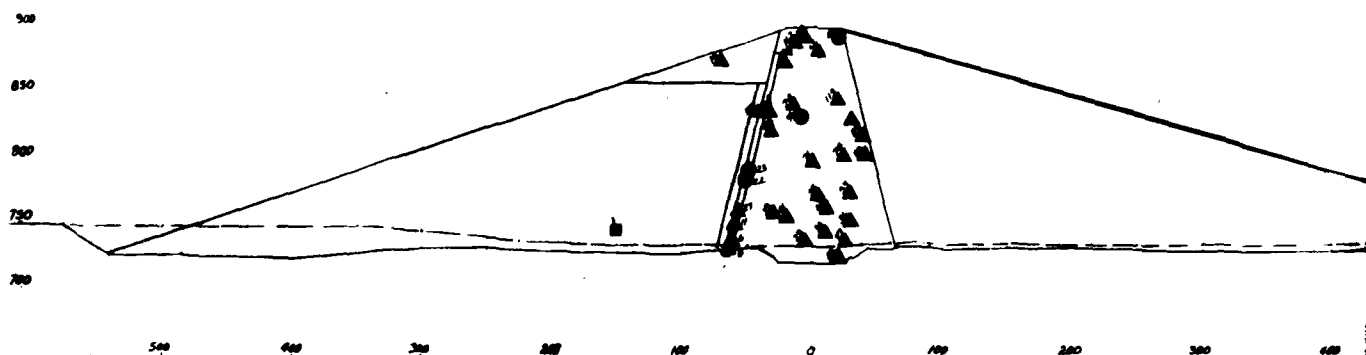
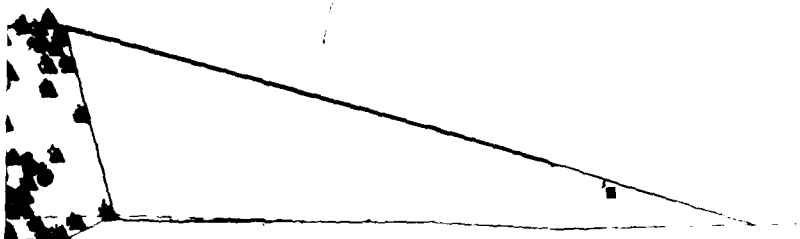
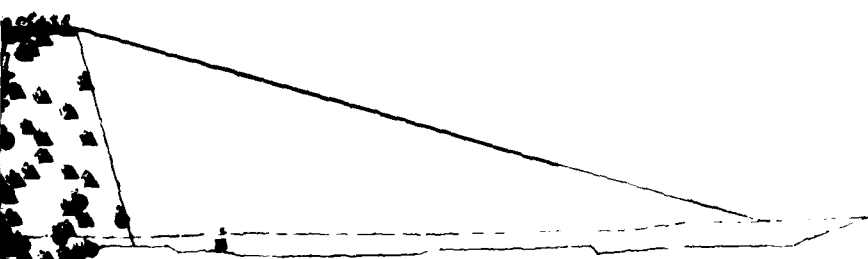
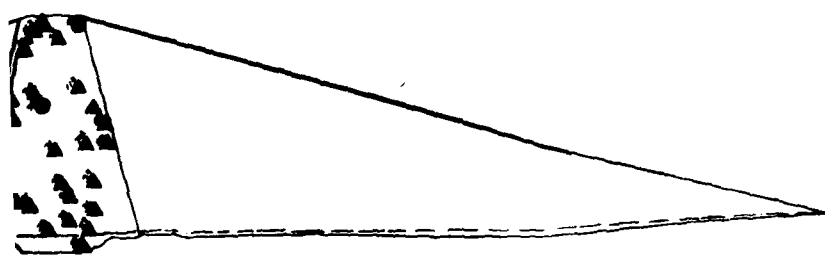
PLATE 19

SAMPLE NUMBER AT
STATION 22+25 22+50 22+75

SAMPLE NUMBER AT

The distribution of density tests performed on the impervious material, the random material and the drain material are shown on plates 18 through 21. A summary of field compaction control test data and design placement requirements for the dam is shown on plate 22. A summary of field compaction control test data and design placement requirements for the dike is shown on plate 23.

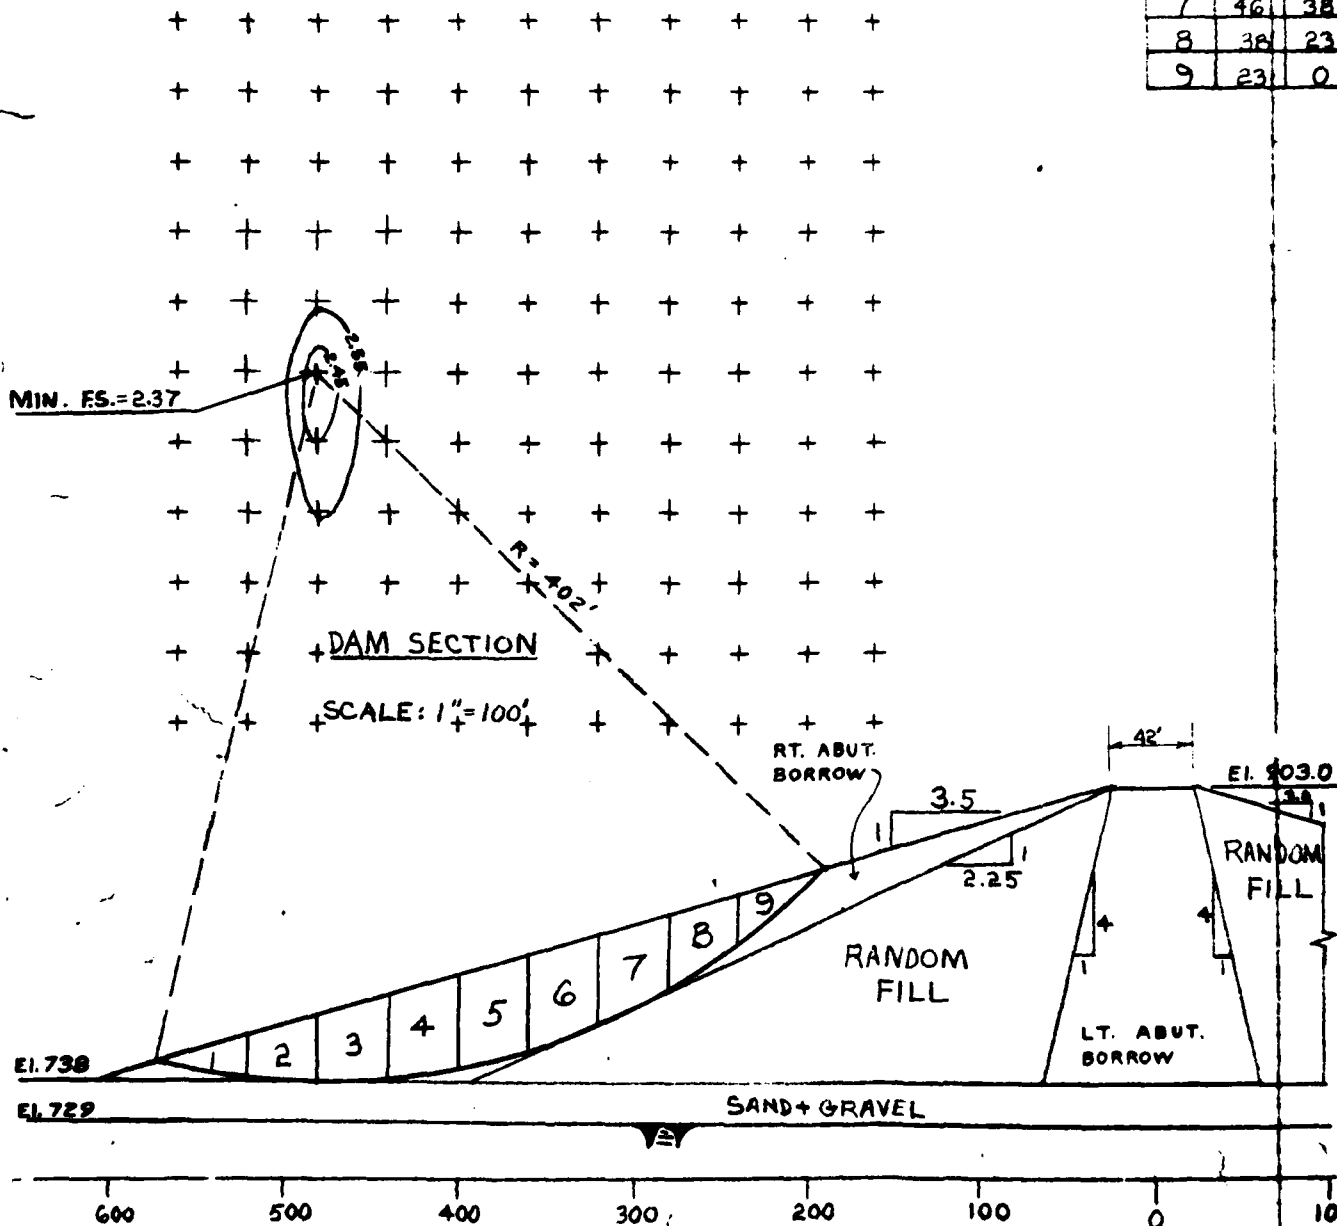
ADOPTED DESIGN VALUES						
MATERIAL	Y (PCF)			*Q* STRENGTH		
	MOIST	SAT	SUB	TAN ϕ	ϕ °	C (TSF)
RT. ABUT. BORROW	132.5	134.6	72.2	0.130	7.4	1.00
LT. ABUT. BORROW	127.0	129.0	66.6	0.071	4.0	1.13
RANDOM FILL	135.0	140.0	77.6	0.368	20.2	1.05

MANUAL COMPUTATION FOR CRITICAL CIRCLE

1. Slope stability computations made with I.B.M. 360 electronic computer using program No.41-K2-H203. The stability of the critical circle was checked with the manual computation shown.
2. A search by the computer showed the most critical type of failure to be an embankment failure tangent to the sand and gravel at elevation 738.
3. Centers of all base circles are shown along with "Factor of Safety Contours." The critical circle is shown on the embankment cross section.

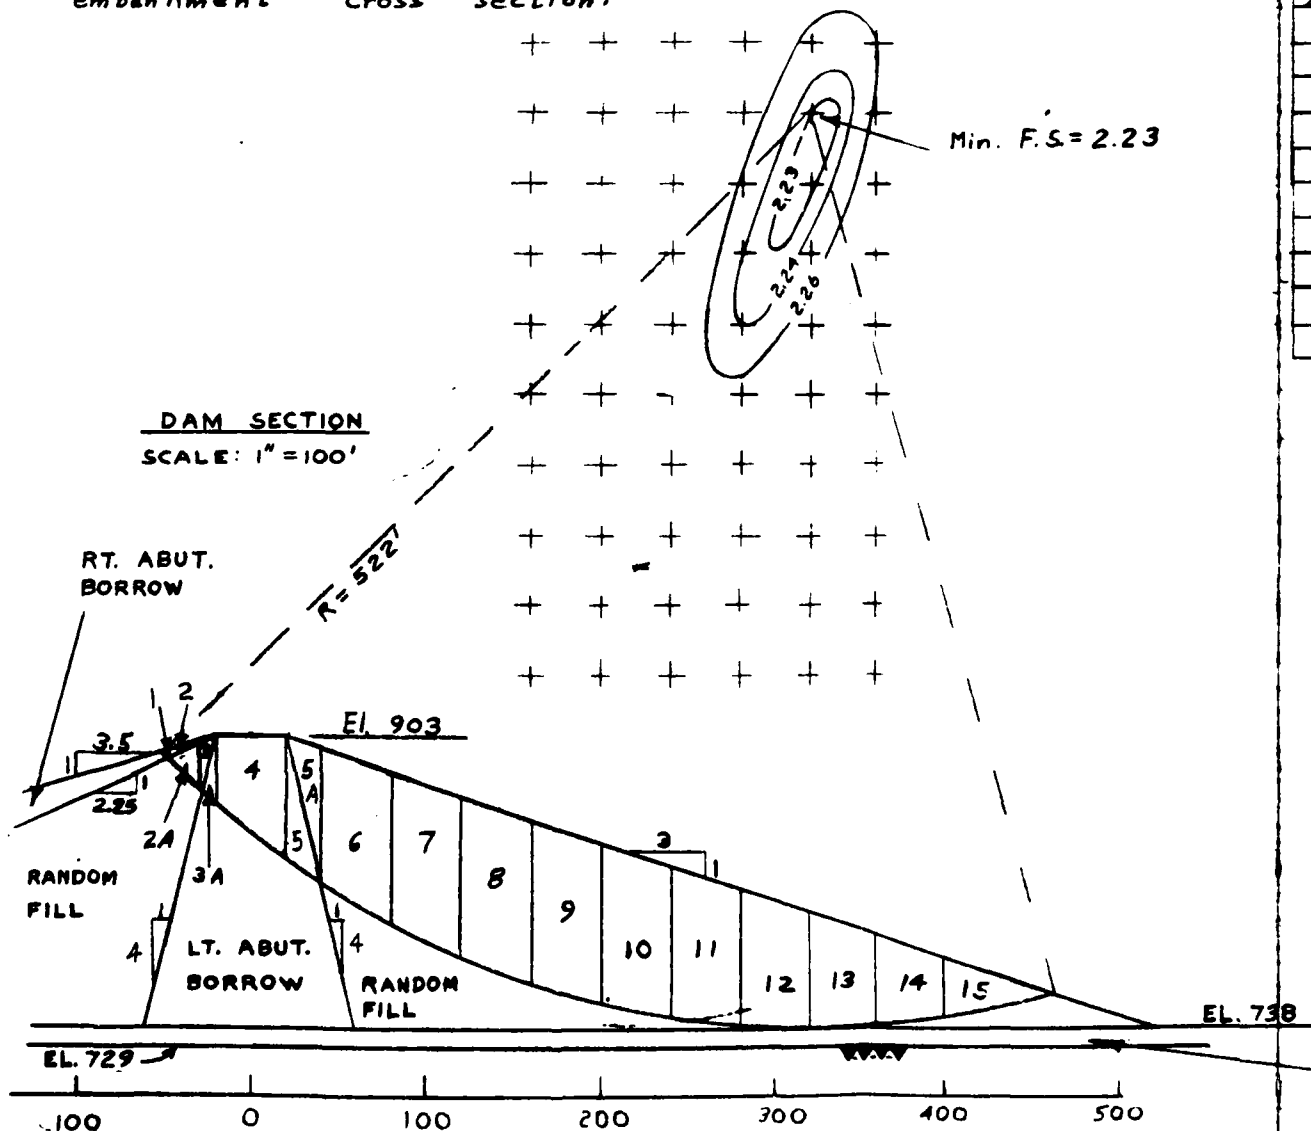
1. Slope stability computations were made with an IBM 360 electronic computer using program No. 41-K2-H203. The stability of the critical circle was checked with the manual computation shown.
2. A search by the computer showed the most critical type of failure to be an embankment failure tangent to the sand and gravel at elevation 738.
3. Centers of base circles are shown along with "Factor of Safety Contours". The critical circle is shown on the embankment cross section.

MANUAL COMPUTATION FOR CRITICAL CIRCLE

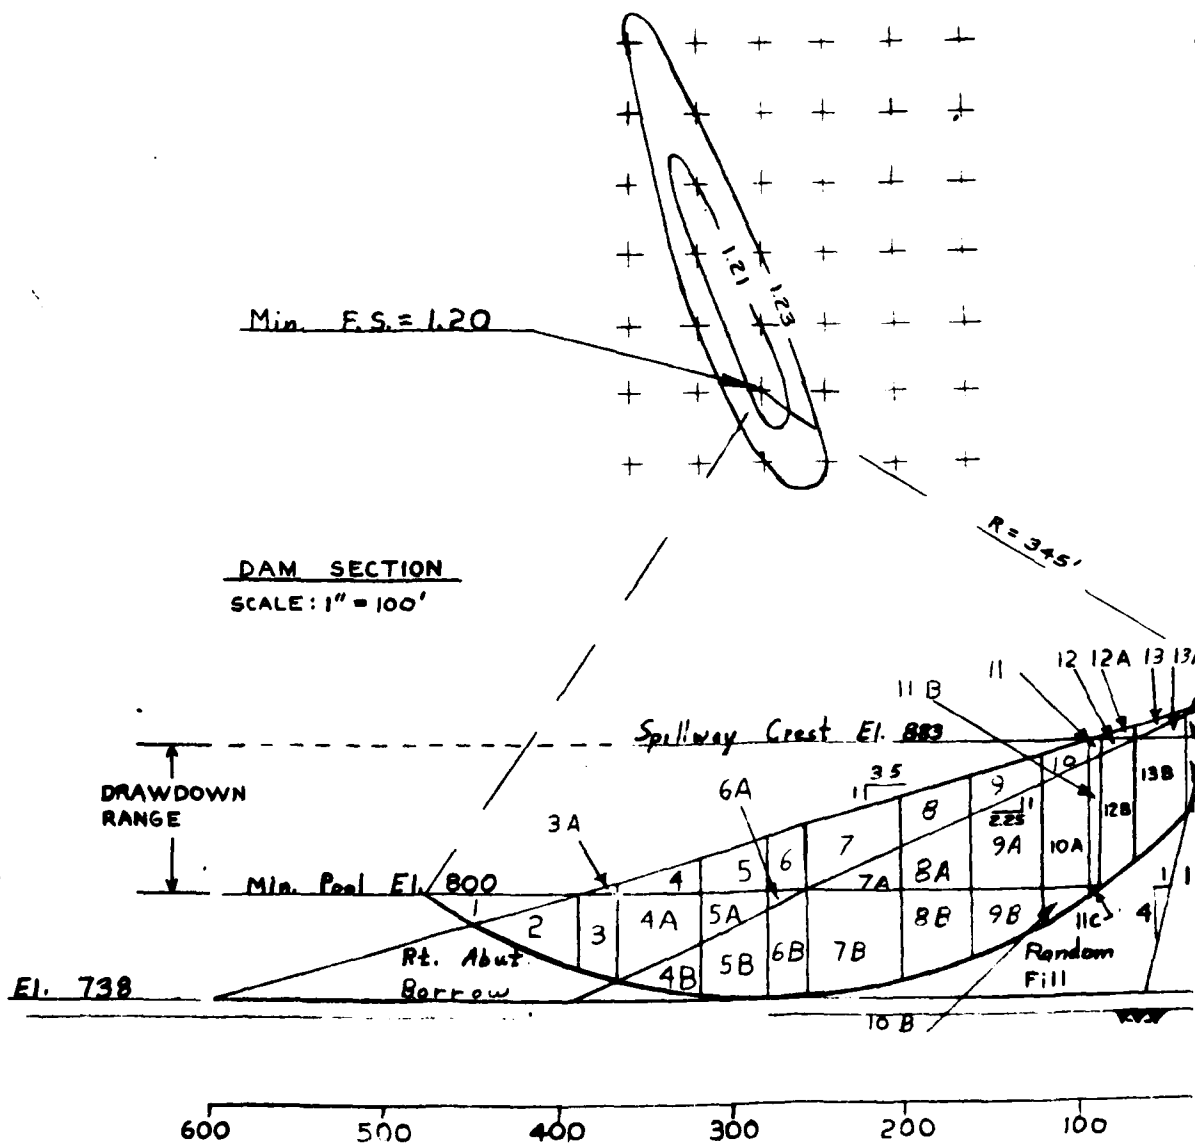
DAM SECTION
SCALE: 1" = 100'

MATERIALS	ADOPTED DESIGN VALUES			STRENGTH	TAN ϕ	C(TSF)
	MOIST	SAT	SUBM	TEST		
RT. ABUT. BORROW	132.5	134.6	72.2	R	0.375	0.30
LT. ABUT. BORROW	127.0	129.0	66.6	R	0.287	0.19
RANDOM FILL	135.0	140.0	77.6	R	0.330	0.50

Min. F.S. = 1.20

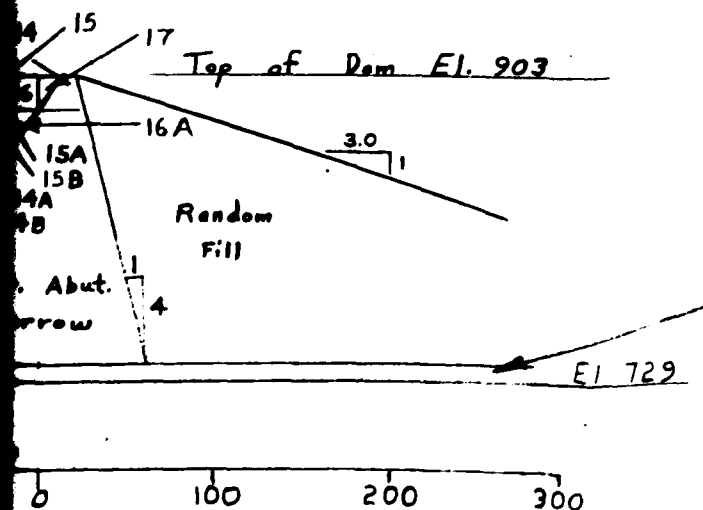
CAESAR CREEK RESERVOIR
STABILITY ANALYSIS
FINITE SLICE METHOD
SUDDEN DRAWDOWN

1. Slope stability computations were made with an IBM 360 electronic computer using program No. 41-K2-H203. The stability of the critical circle was checked with the manual computation shown.
2. A search by the computer showed the most critical type of failure for sudden drawdown to be an embankment failure tangent to the sand and gravel at elevation 738.
3. Centers of all base circle are shown along with "Factor of Safety Contours." The critical circle is shown on the embankment cross section.

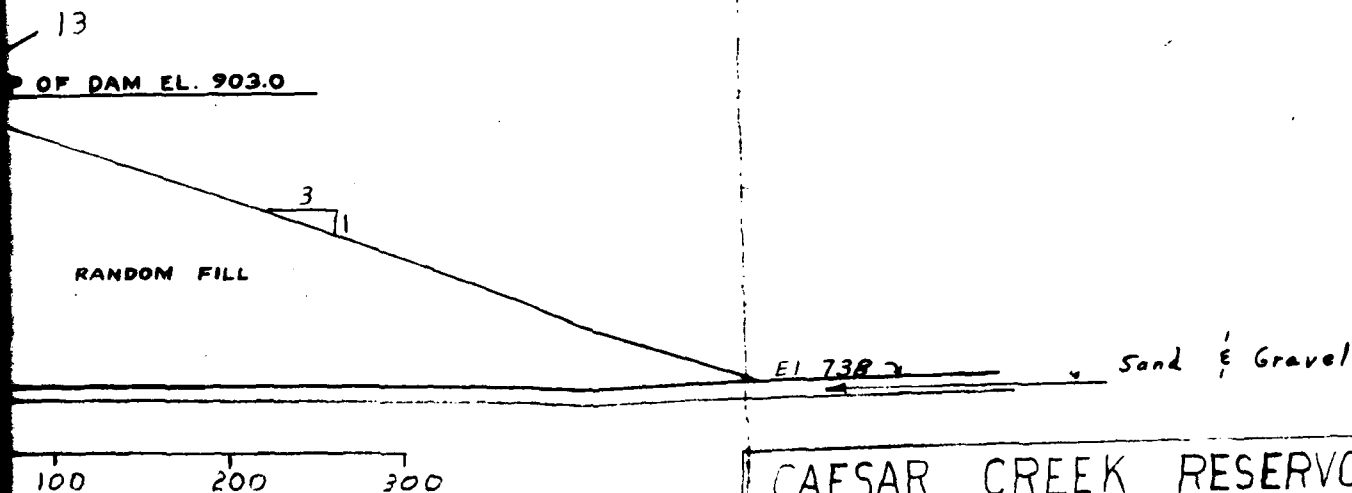
CAESAR CREEK RESERVOIR
STABILITY ANALYSIS
FINITE SLICE METHOD
PARTIAL POOL

1. Slope stability computations were made with an IBM 360 electronic computer using program No. 41-K2-H203. The stability of the critical circle was checked with the manual computation shown.
2. A search by the computer showed the most critical type of failure to be an embankment failure tangent to the sand and gravel at elevation 738.
3. Centers of all base circles are shown along with "Factor of Safety Contours". The critical circle is shown on the embankment cross section.

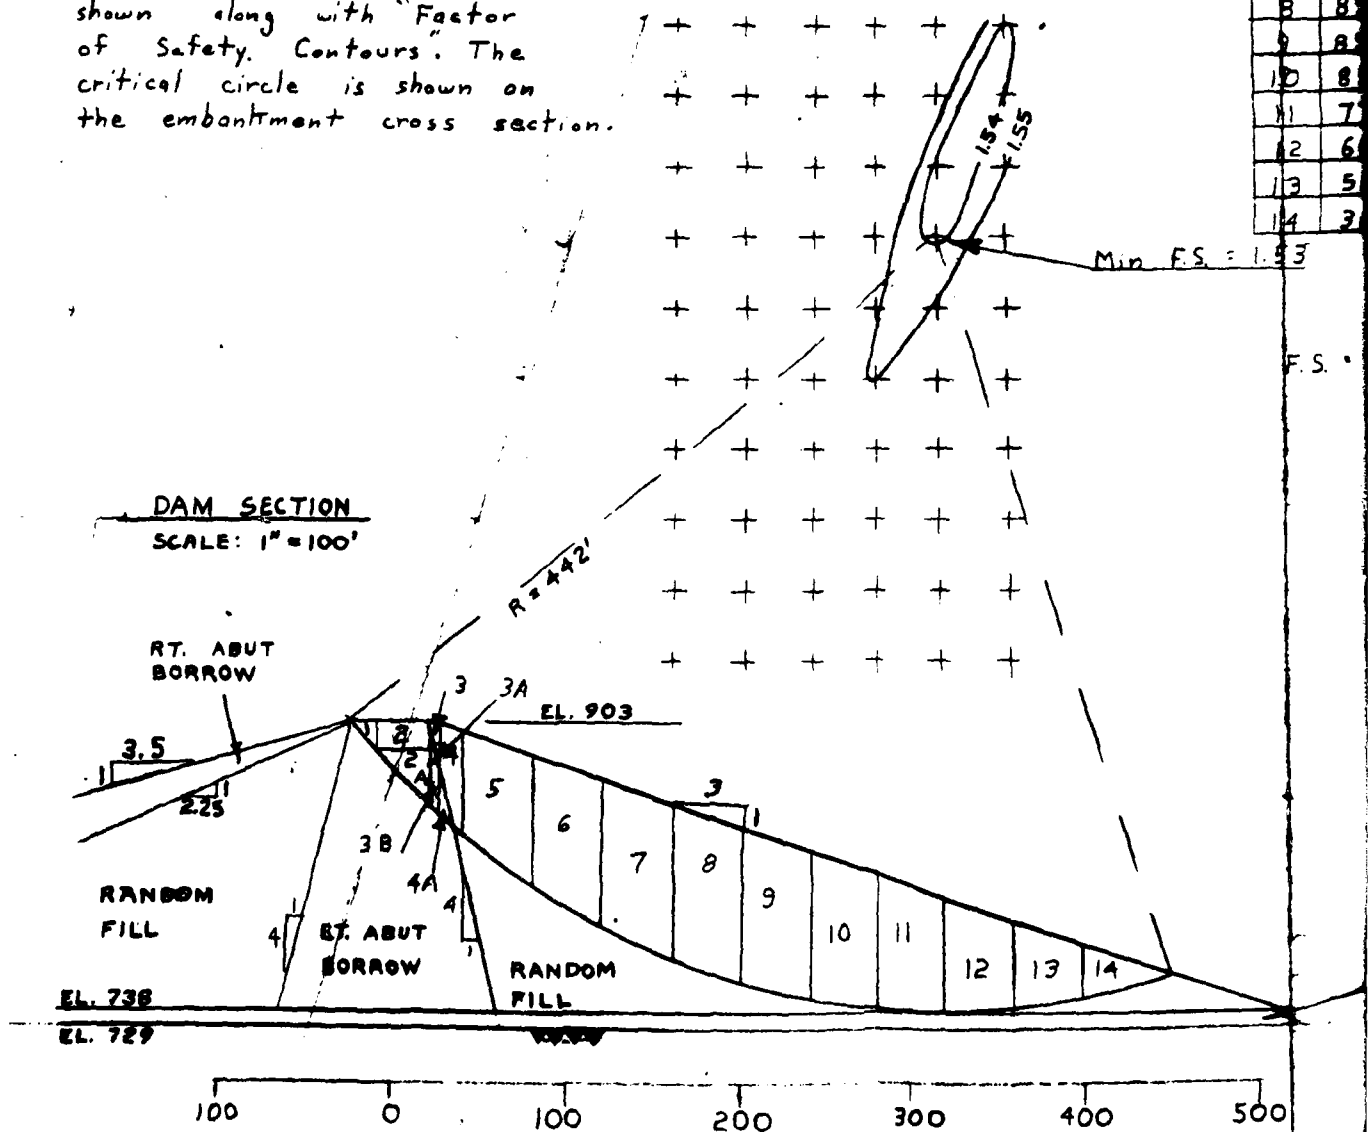
1. Slope stability computations were made with an IBM 360 electronic computer using program No. 41-K2-H203. The stability of the critical circle was checked with the manual computations shown.
2. A search by the computer showed the most critical type of failure for Steady Seepage to be an embankment failure tangent to the Sand and Gravel at elev. 738. The "R" case yielded a F.S. = 1.53 and the "S" case 2.01. Since the "S" case is greater than the "R" case, the average F.S. = $(1.53 + 2.01) / 2 = 1.77$.
- 3 Centers of all base circles shown along with "Factor of Safety, Contours". The critical circle is shown on the embankment cross section.

SIDE	HT. LT.	HT RT.	AVG WIDTH		AREA	\bar{X}	$\sin \alpha$	$\cos \alpha$	NORMAL FORCES		COHESION		TANGENTIAL FORCES	
	FT.	FT.	FT.	FT.	FT ²	FT.	$\frac{\bar{X}}{R}$		γ_{eff}	W_{eff}	N_{eff}	T_{eff}	γ	W
									PCF	KIPS	KIPS	KIPS	PCF	KIPS
0	21	10.5	16	168	331	.749	.663	127.0	21.3	14.1	.287	4.0	26	38
21	21	21	27	567	313	.708	.706	127.0	72.0	50.8	.287	14.6	0	35
0	27	13.5	27	3645	309	.699	.715	66.6	24.3	17.3	.287	5.0	38	14.4
0	21	10.5	6	63	296	.670	.742	135.0	8.5	6.3	.287	1.8	0	35
21	0	10.5	6	63	297	.672	.741	127.0	8.0	5.9	.287	1.7	0	38
26	31	28.5	6	171	296	.670	.742	66.6	11.4	8.5	.287	2.4	8	38
21	56	38.5	10	385	287	.649	.761	135.0	51.9	39.5	.287	11.3	0	38
31	0	15.5	10	155	290	.656	.755	66.6	10.3	7.8	.287	2.2	13	38
56	75	65.5	44	2882	261	.590	.807	135.0	389.0	313.9	.330	103.6	55	1.0
75	84	79.5	40	3180	220	.498	.867	135.0	429.3	372.2	.330	122.8	46	1.0
84	89	86.5	40	3460	180	.407	.913	135.0	467.1	426.5	.330	140.7	44	1.0

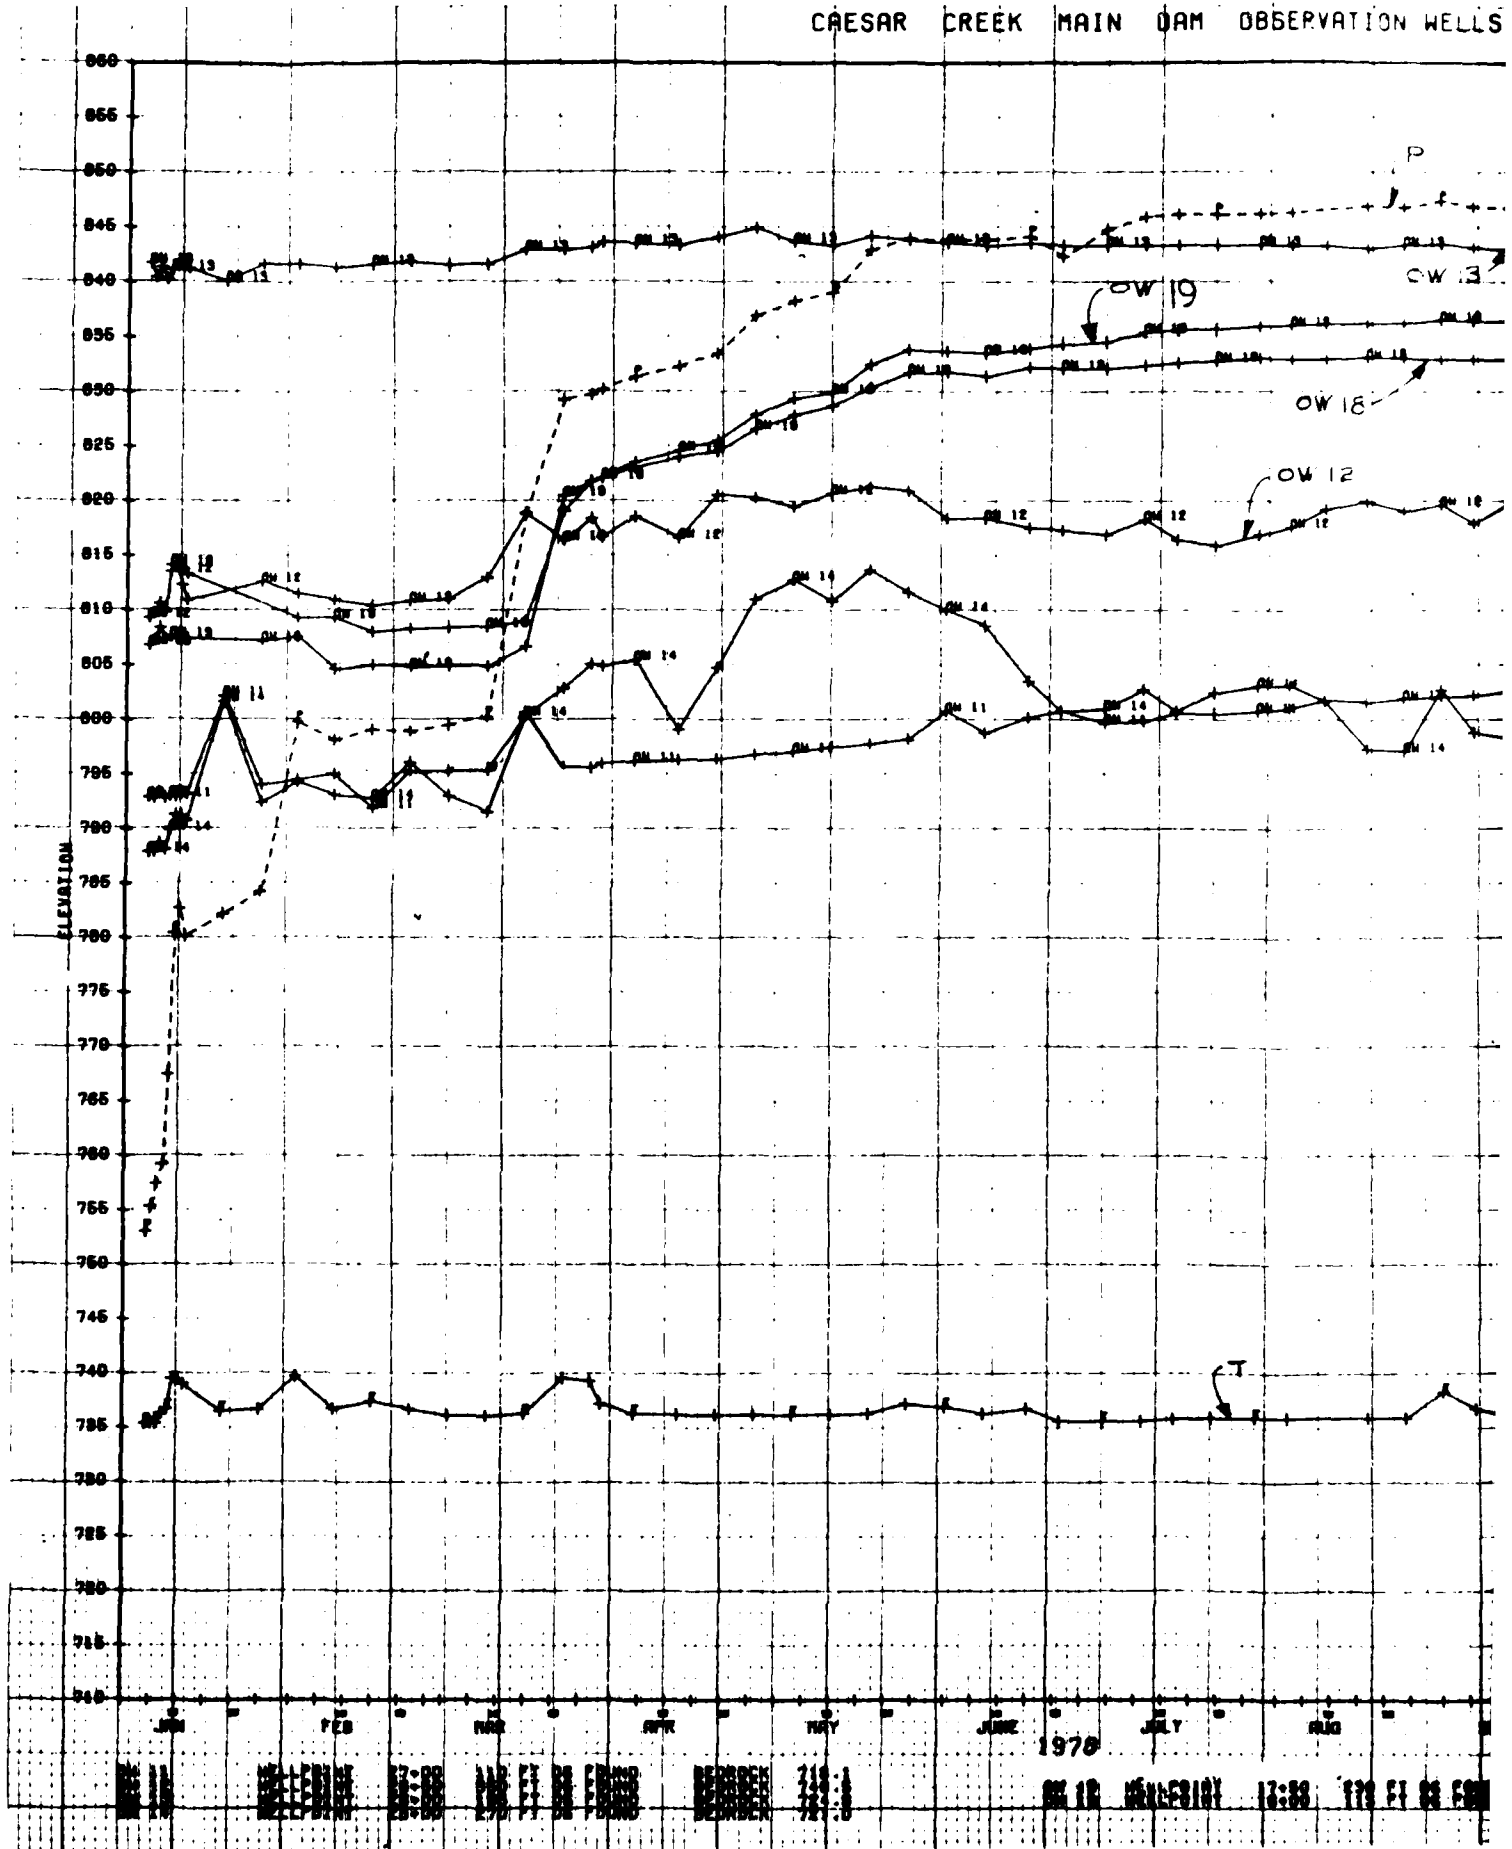
CAESAR CREEK PIEZOMETERS DAM STA 21

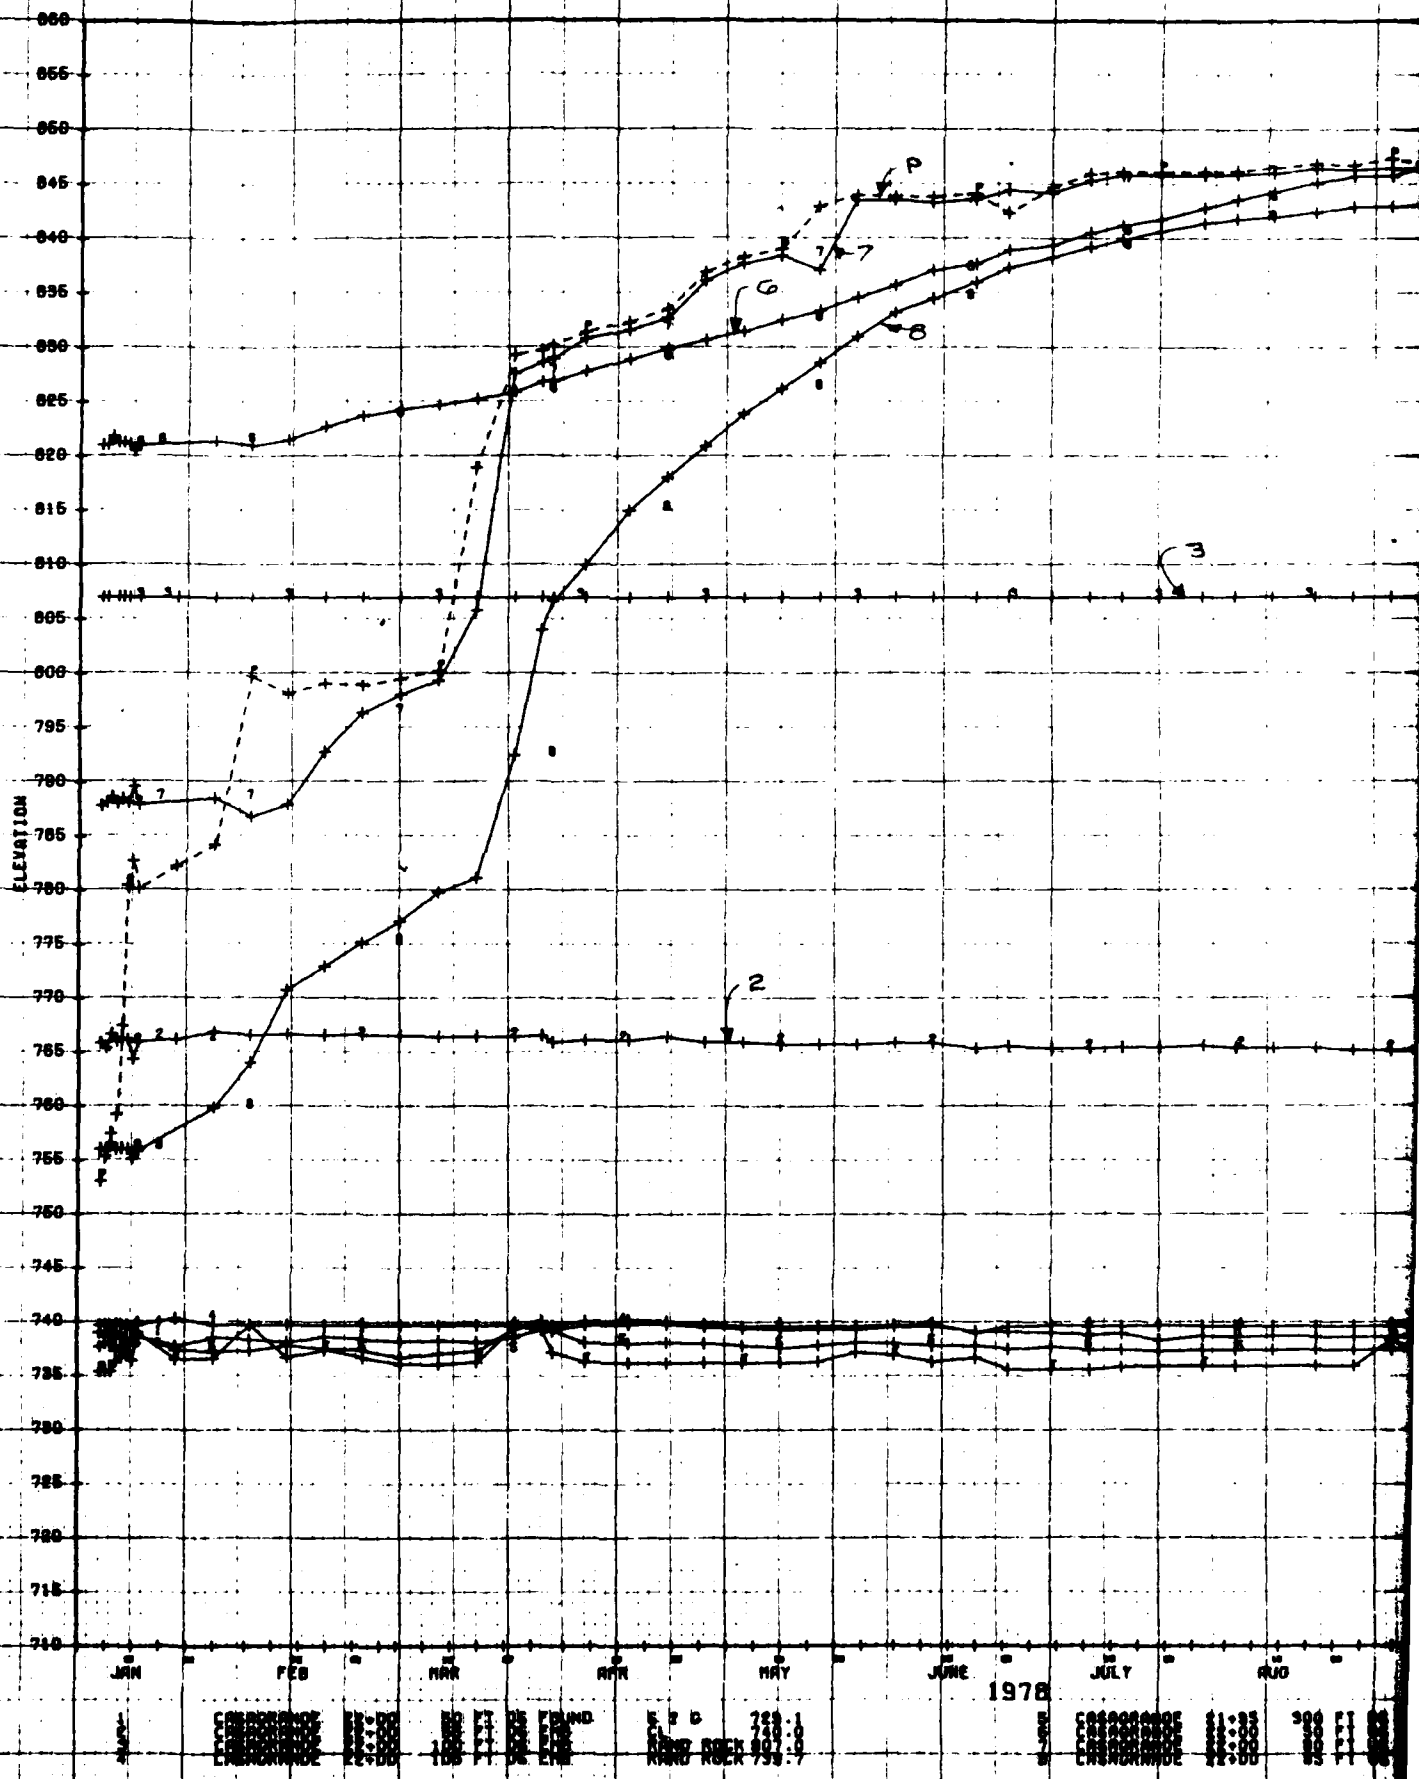
CAESAR CREEK PIEZOMETERS DAM STA 21+95 TO 22+00

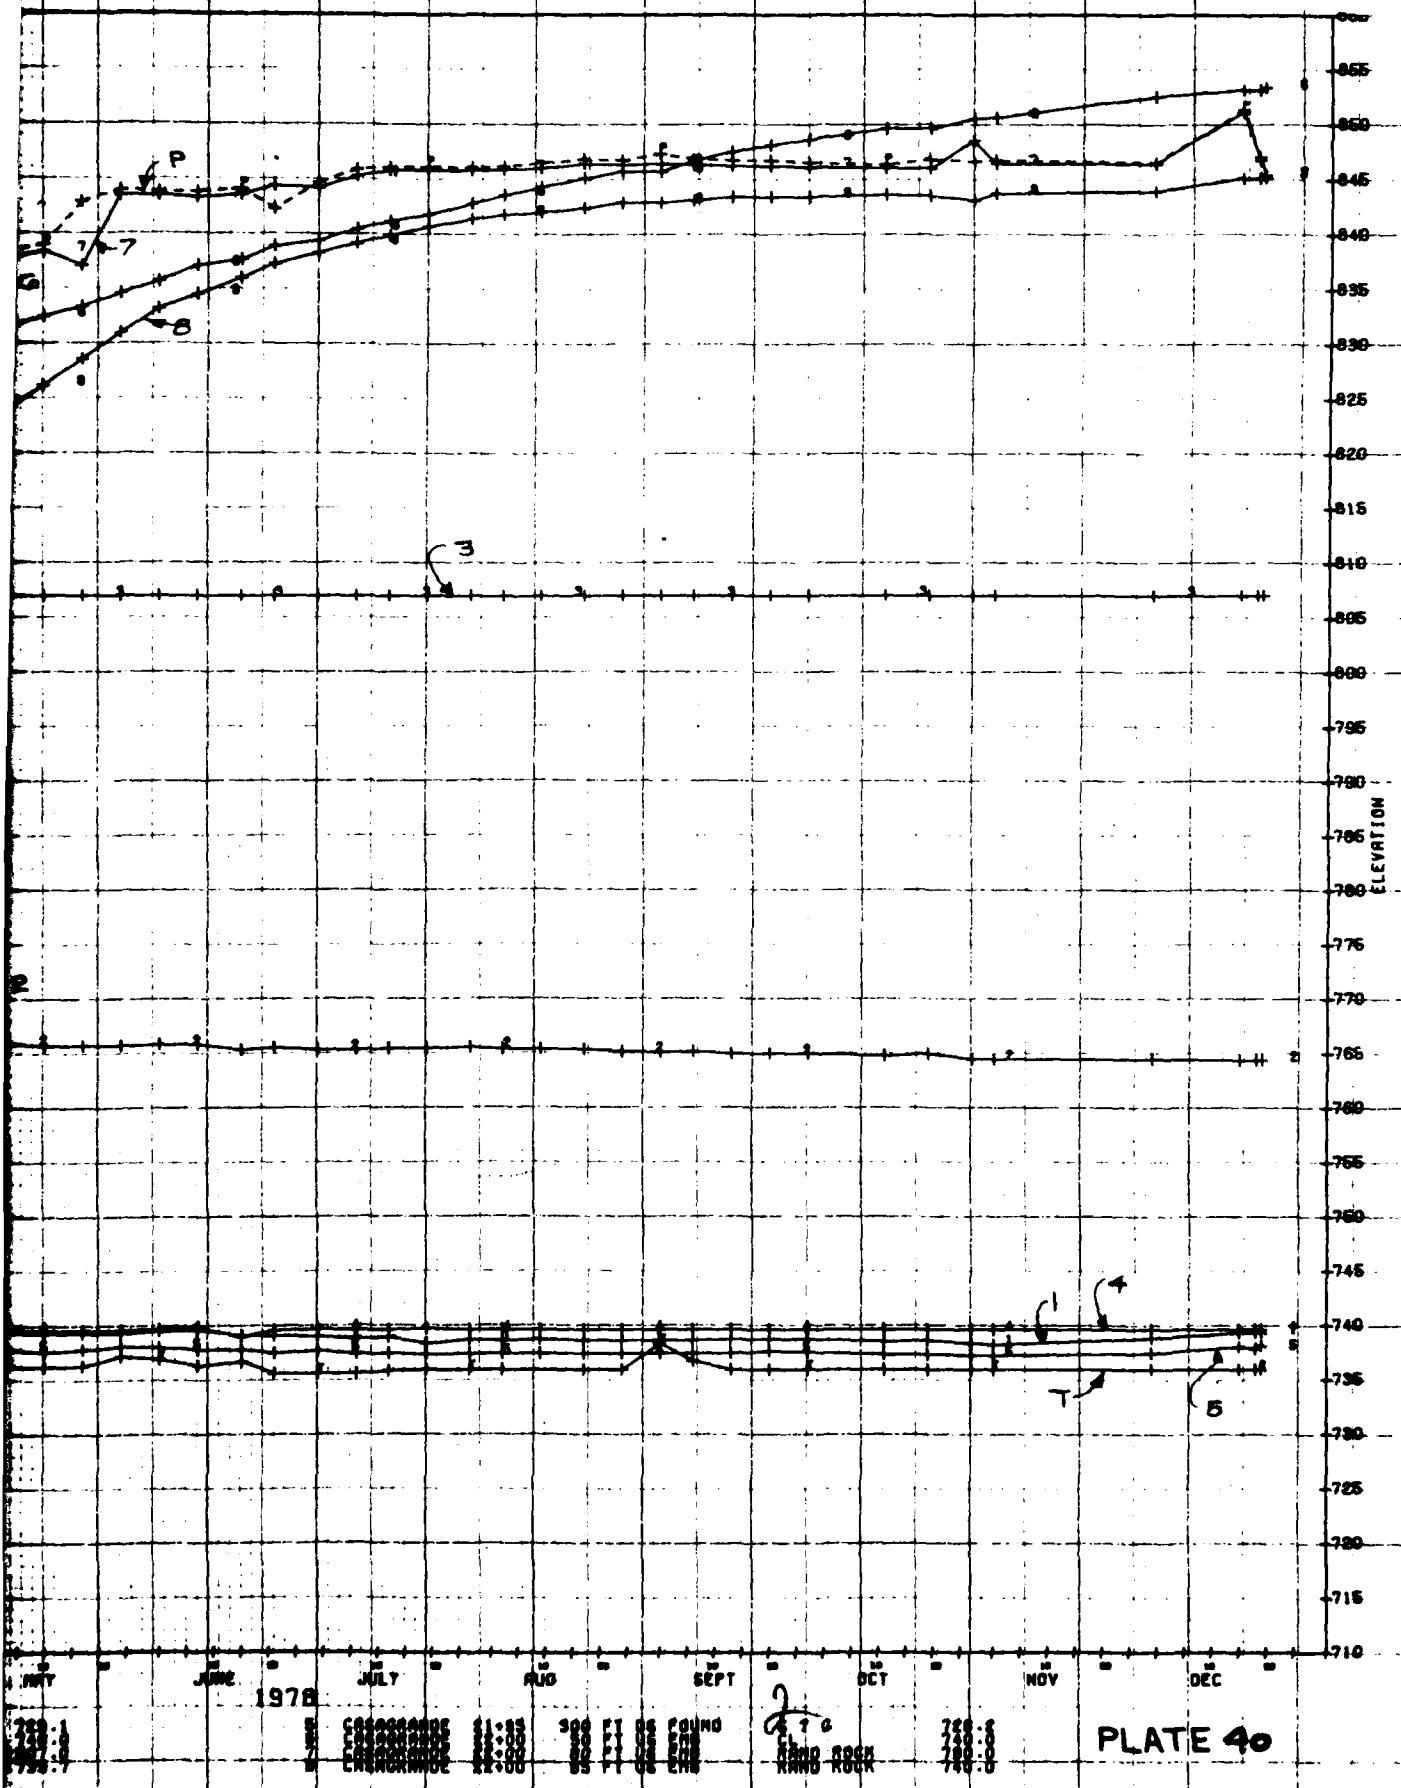
CAESAR CREEK PIEZOMETERS DAM STA 26+55 ? OBS WELLS AT 21+00 +22+50

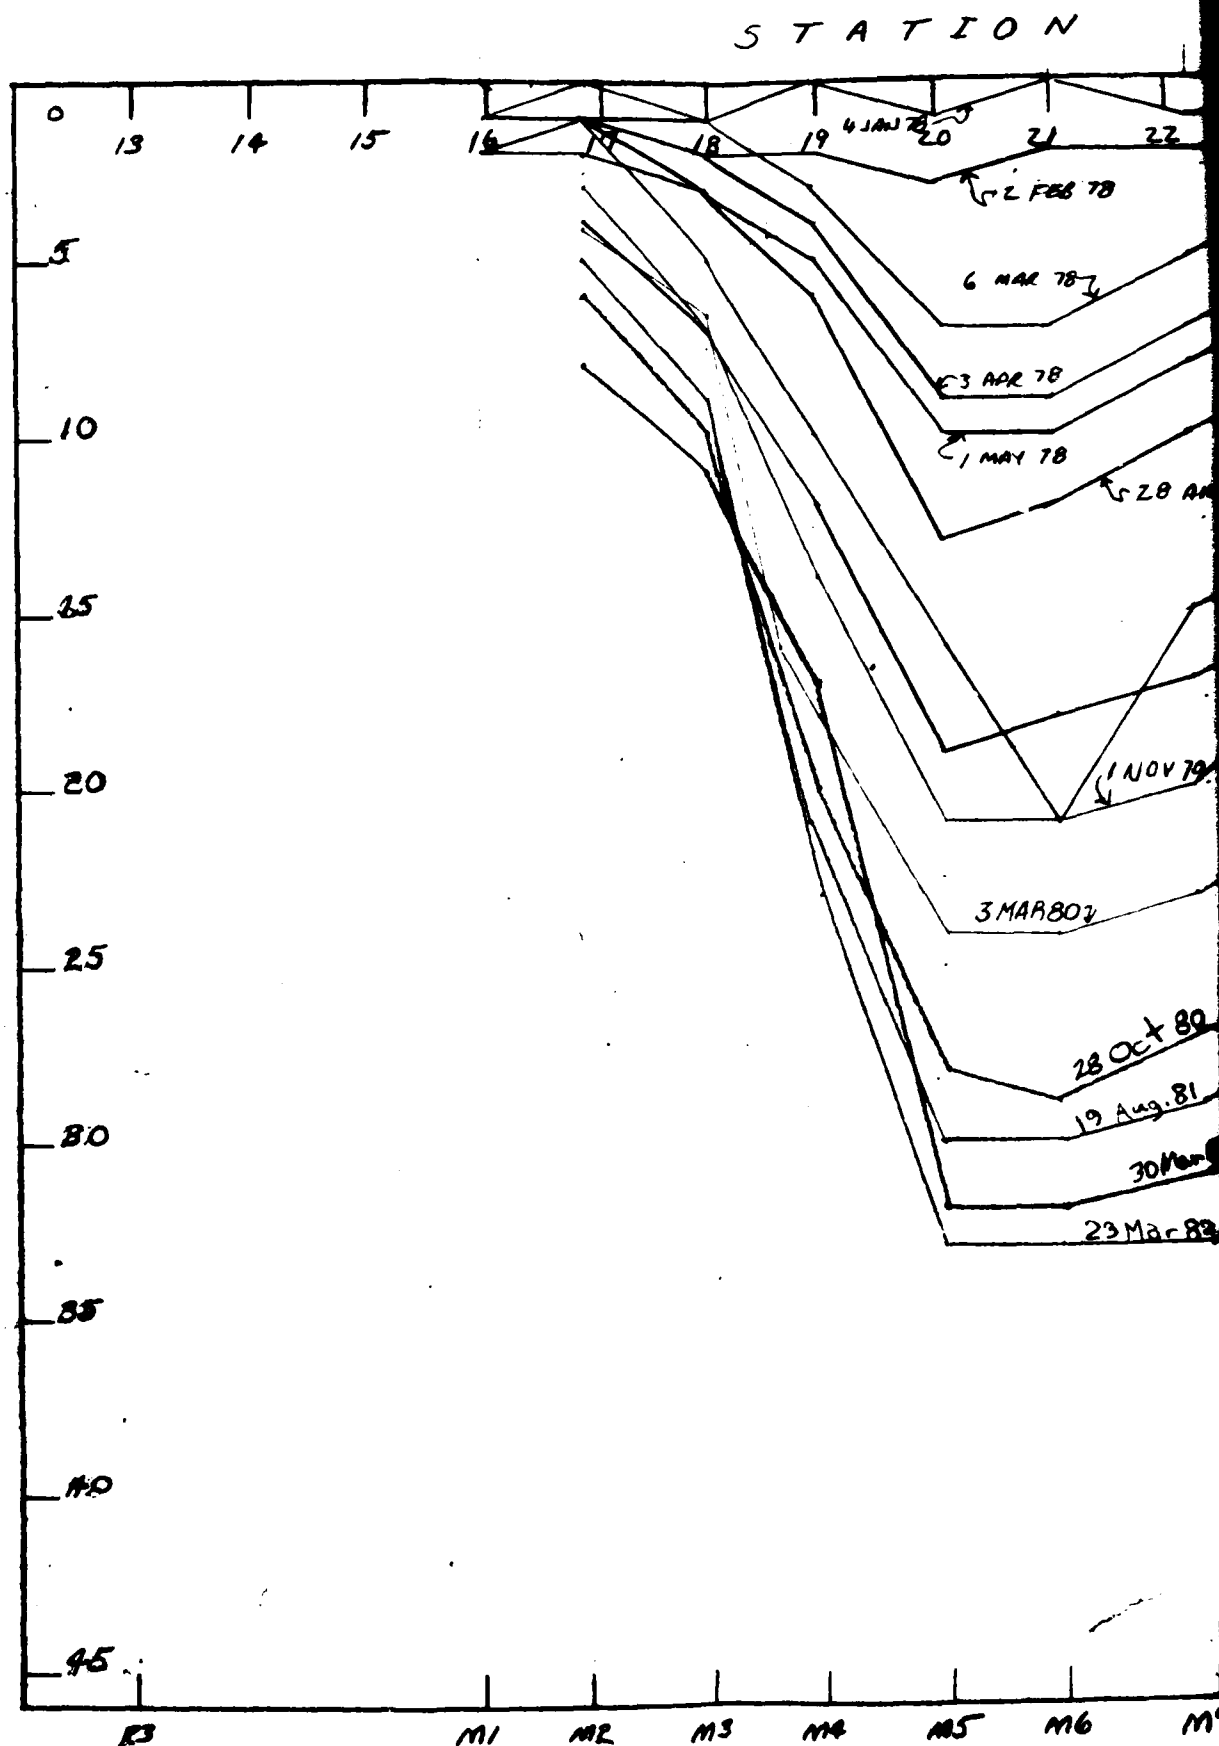
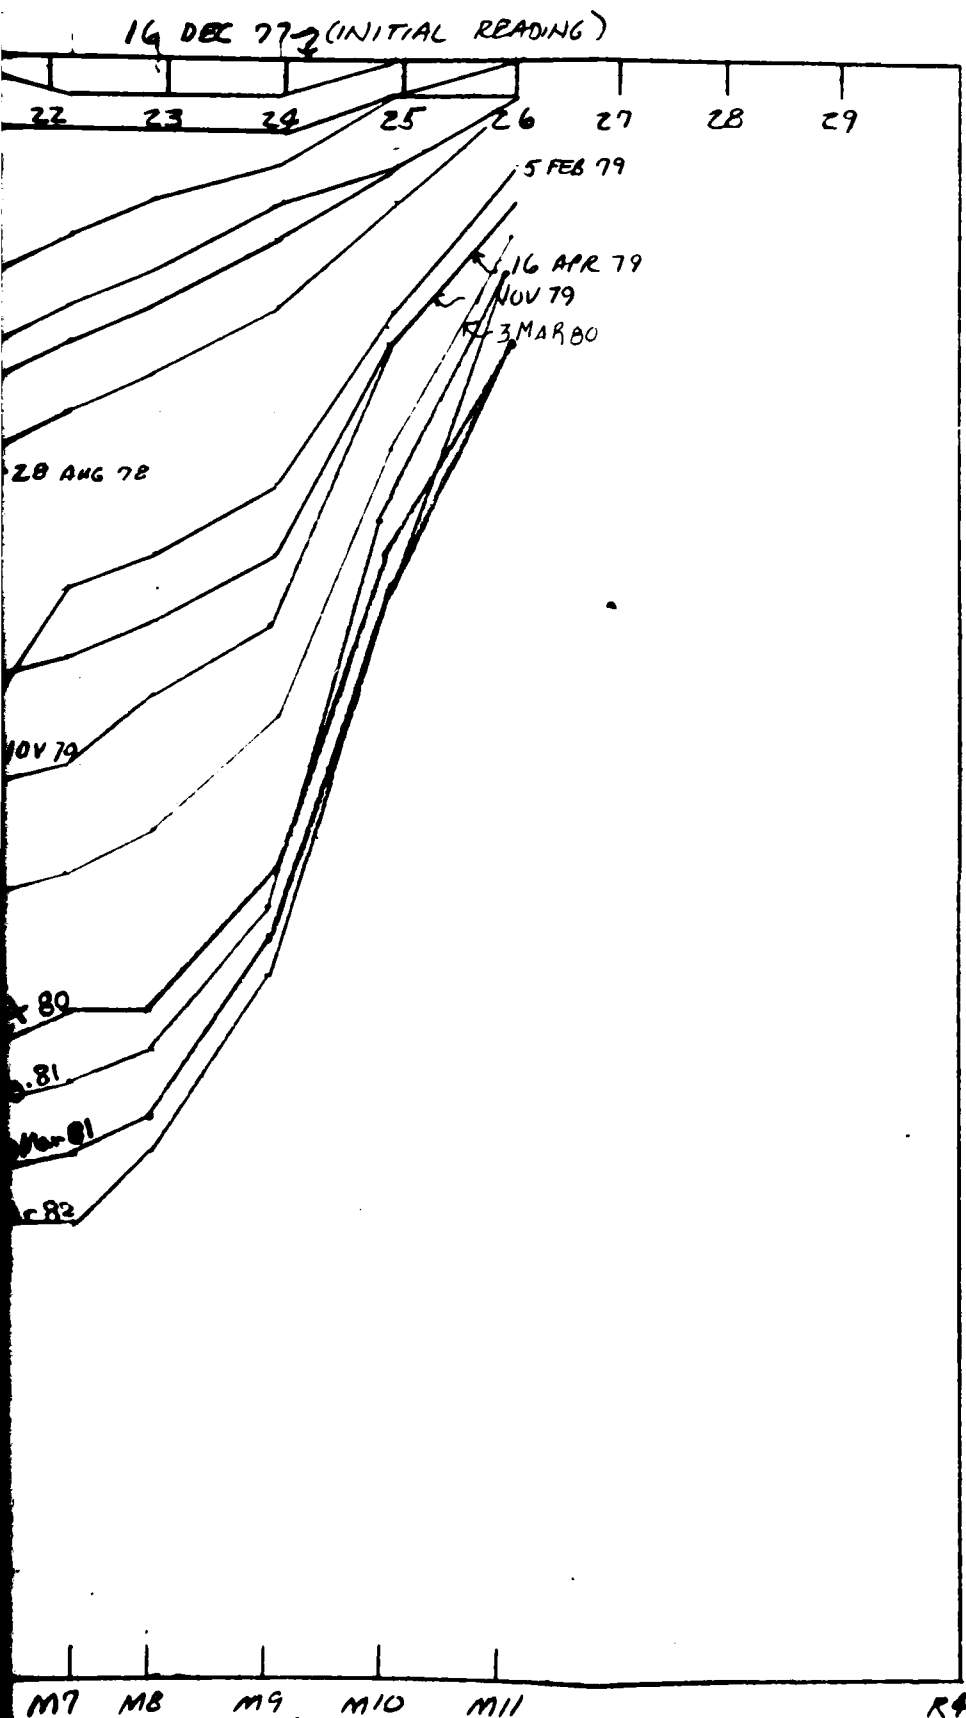
PLATE 42

CUMULATIVE VERTICAL MOVEMENT
(HUNDRETHS OF A FOOT) ↓ DOWN

CAESAR CREEK
MOVEMENT MARKERS
20' D.S. &
VERTICAL MOVEMENT

MOVEMENT MARKERS	INITIAL READINGS
M-1	902.74
M-2	902.48
M-3	902.53
M-4	902.37
M-5	901.98
M-6	901.90
M-7	901.91
M-8	902.04
M-9	902.59
M-10	903.25
M-11	903.84
